SCHOOL FACILITIES ASSESSMENT

Watertown Public Schools, Watertown, Massachusetts

PRELIMINARY QUALITATIVE EVALUATION DOCUMENT

March 13, 2014

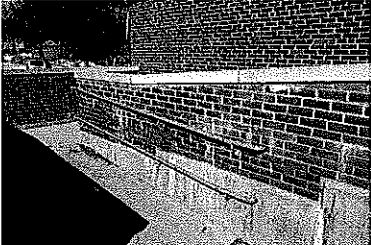
Photo 3
Efflorescence at south entrance site walls (Old Hosmer Building). Red arrow points to location of vertical crack in brick masonry.
